Manhole Inspection Summary

Manhole # S25CC1019MH

Location Address: **1236 UNION AVE**

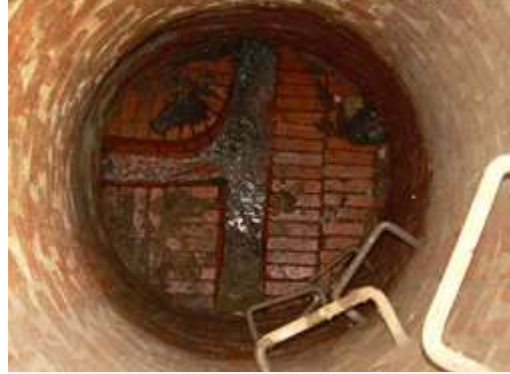
Top View

Evidence of surcharge - Bench debris.
Channel debris.

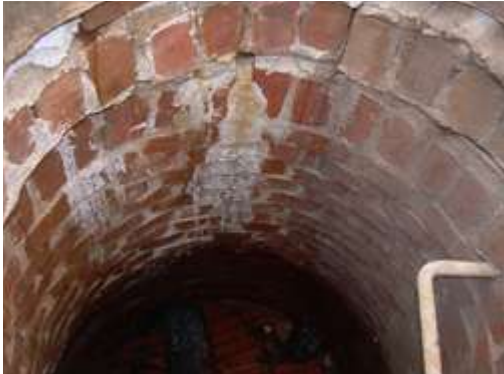
Defect

Frame leaks. Adjustment deterioration
and infiltration. Barrel infiltration.

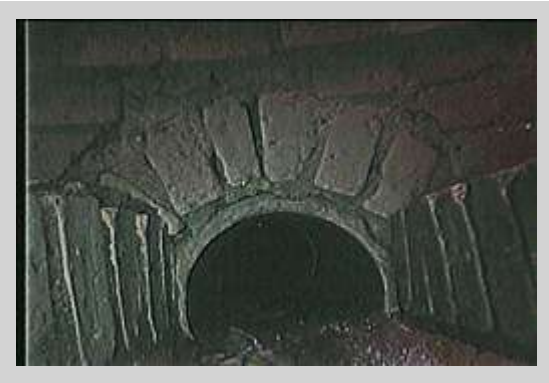
8 in. Circular Gravity Sewer
Pipe Out @ 12 O'Clock

Barrel deterioration and infiltration. Channel deterioration.

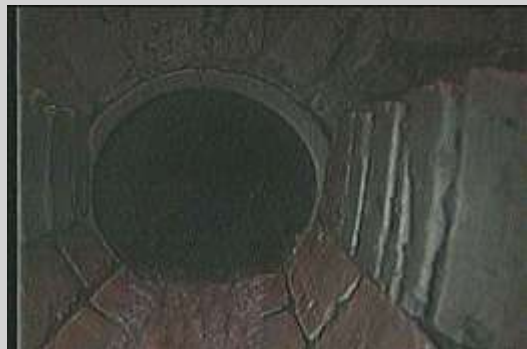
Pipe In @ 9 O'Clock

Pipe Seal Cond: **Cracked**
